Section # 4.1 - Interior Review (Console, Floor, Seating and, Under dash)

ICCA – Interior Review Plymouth B Body - Section # 4.1

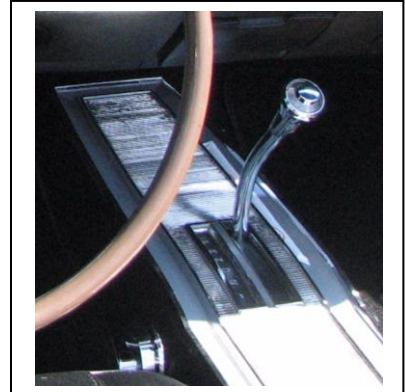
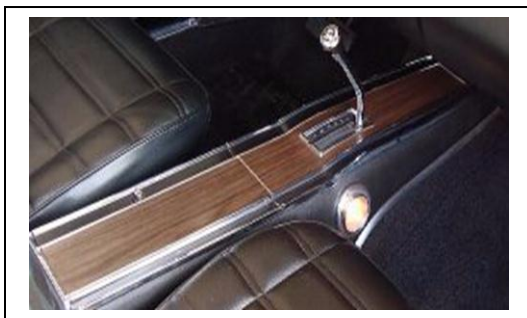
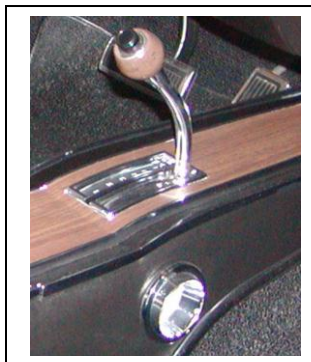
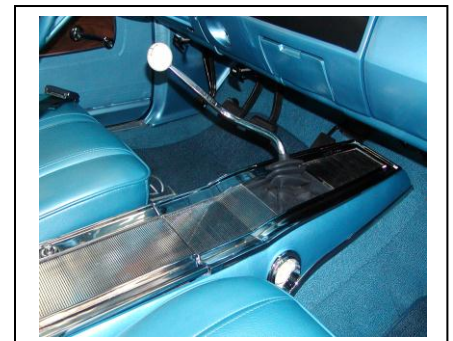
1968 4 speed Console

There are two configurations of consoles . One for the manual and one for the automatic transmission cars. The manual transmission console is very similar to the automatic transmission. However, there is plastic material removed from the left side of the manual transmission and a special detail added to facilitate the special floor pan used. The console is molded plastic.

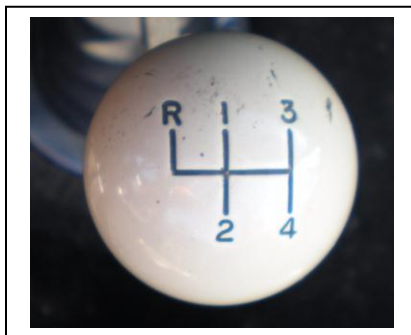
Hurst shifter ball – White aftermarket .

Note: Reproduction Balls : Not only is the color or grain on the wood grain not quite right, the 4 speed pattern is molded into the part when it is made, versus being heat melted into the ball as the originals were.

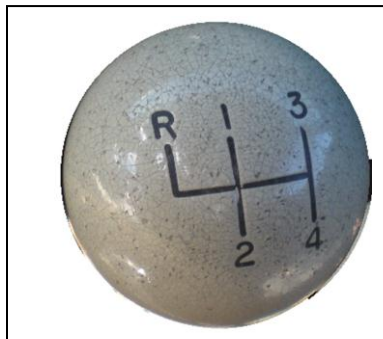
Original Hurst shifter ball – White the distance between the 1 and R is greater then on the after market one.

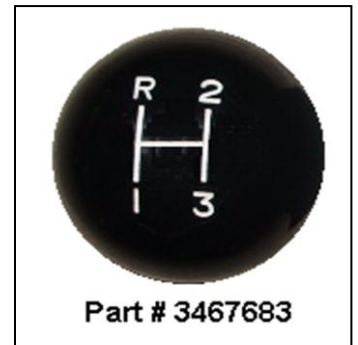
Hurst shifter ball – Black. Early part # 2950217.

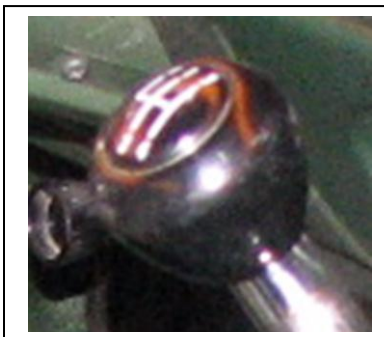
Inland shifter knob

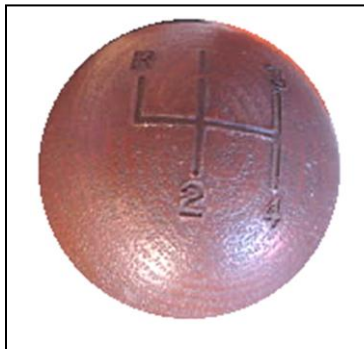
#2950213 Wood grain Ball

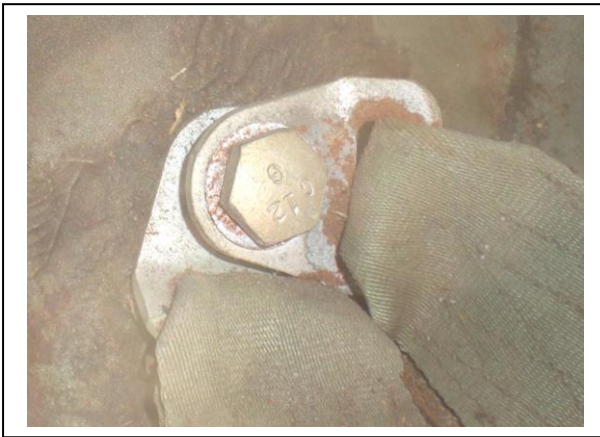
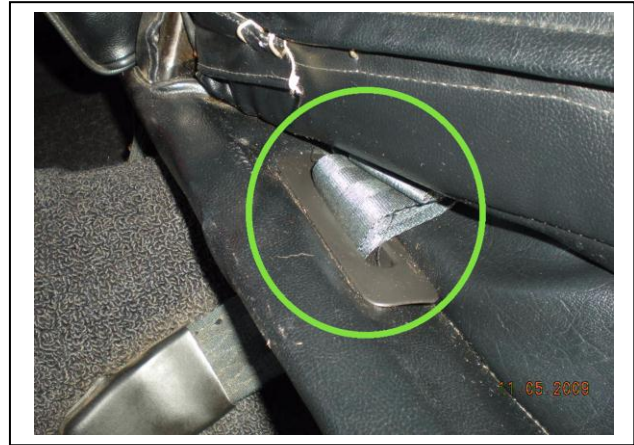
Rear seat belt to floor pan mounting reference

There should be a plastic guide between the top and the bottom seat to guide the belt

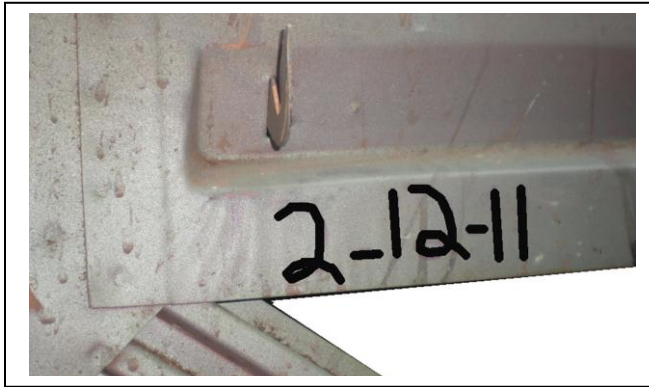
1970 Coronet 4 door Built at Lynch Road Assembly on June 6, 1970. F4 Interior, F4 Exterior Interior and green vinyl top

We have found factory code markings on the front face of the package tray of B bodies. This marking is always in the same location on the right side of the package tray. Typically there are three sets of characters and often the first set sometimes repeats itself and the last set is different. This information has been found on Lynch Road, St. Louis and Los Angeles and Hamtramck Assembly Plant built car from 1963 to 1976

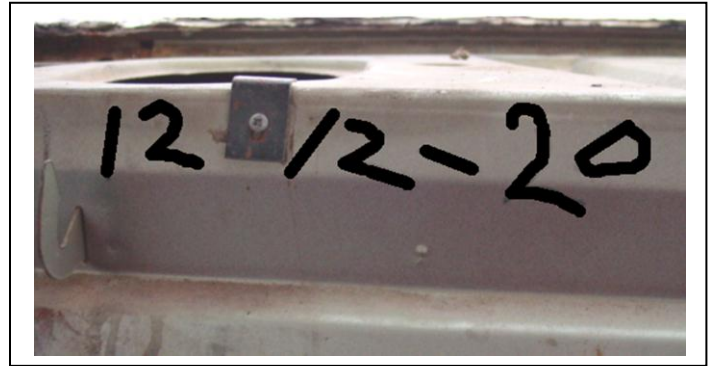
1968 Road Runner RM21 Built at St. Louis Assembly Plant on March 14, 1968. Red Interior, black Interior and black vinyl top

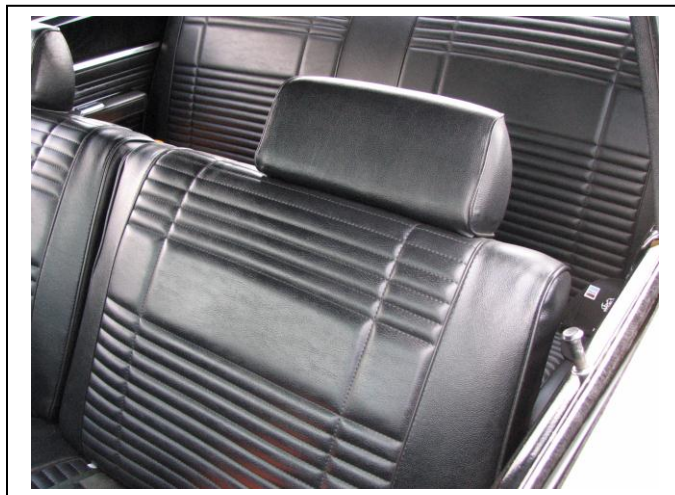
1969 Plymouth Road Runner - H2 Code
Reproduction covers

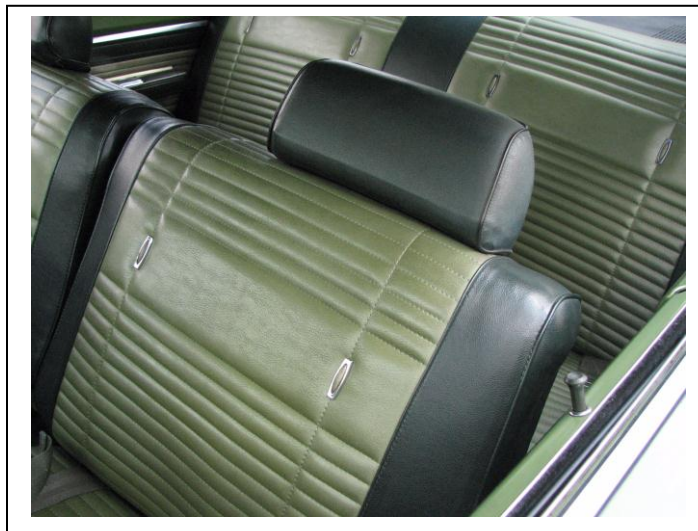
1969 Plymouth Road Runner - H2 Code Original

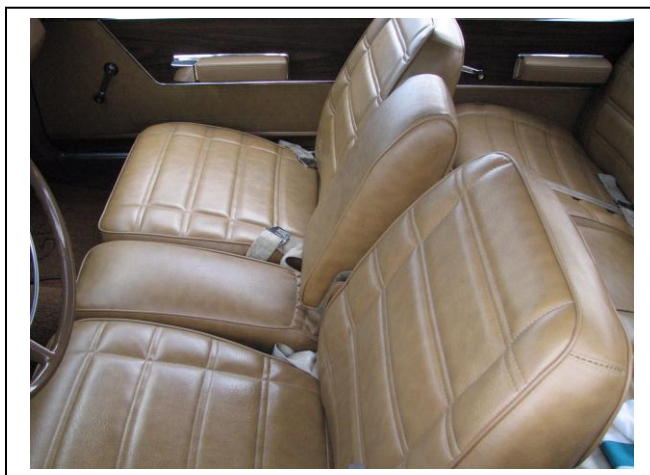
1969 Plymouth GTX - P6T Code

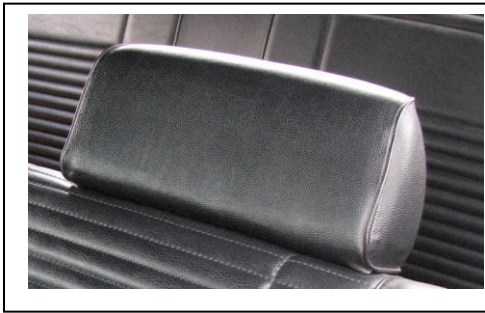
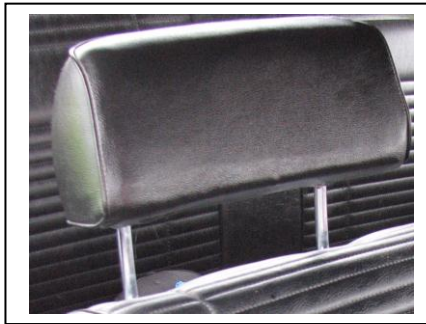
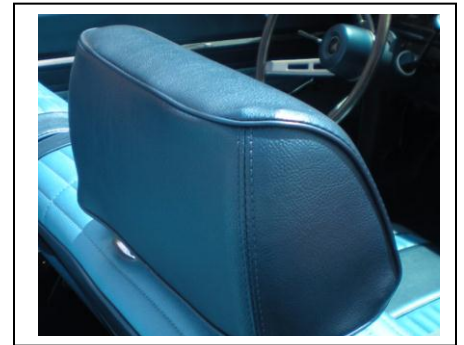
Reference "A" - 1969 Bucket seat and 1968-69 Bench seat

Hear restraints became standard equipment on all Chrysler Corporation products after January 1, 1969. There were two style head rests used from 1968-70. Both were vinyl covered with dual chrome support posts and chrome receiver bezels that were mounted to the top of the seats. One is oval shaped with a chrome bars around the length of the head rest. The other style is triangular shaped.

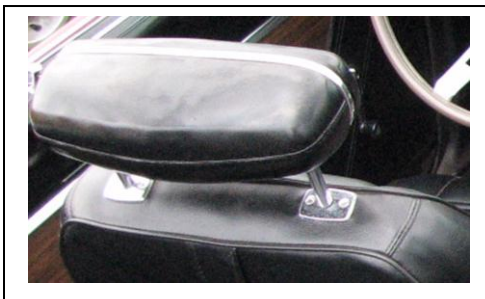
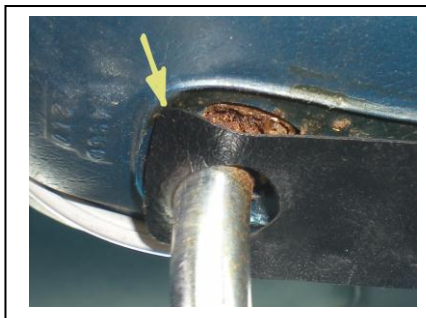
There should be a black plastic trim detail that cover the bottom side of the head restraint

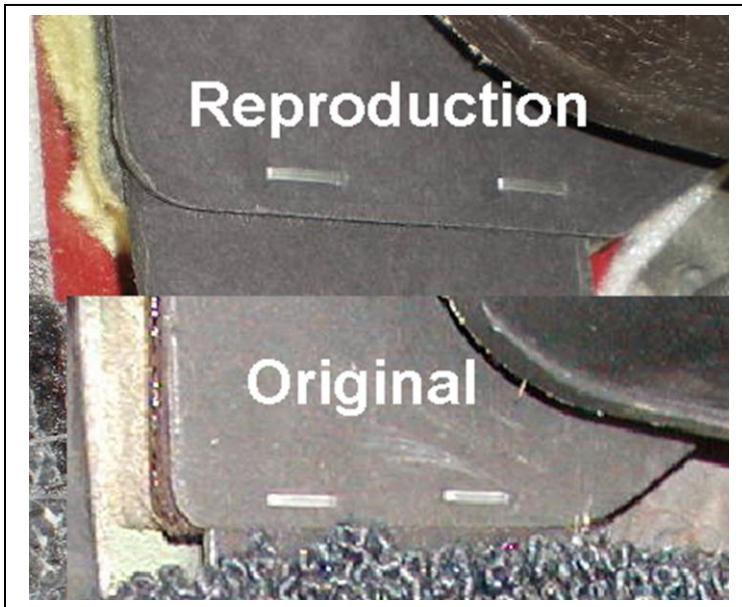
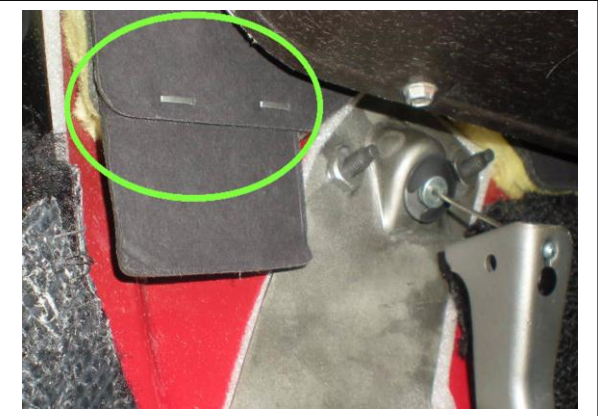
Aftermarket reference

Note: The original and reproduction can be identified by the position of the staples and the radius on the corner of the fiber board. The original ones have a smaller radius on the corners. Also the position of the lower fiber board that is attached to the upper one is offset on the original one.

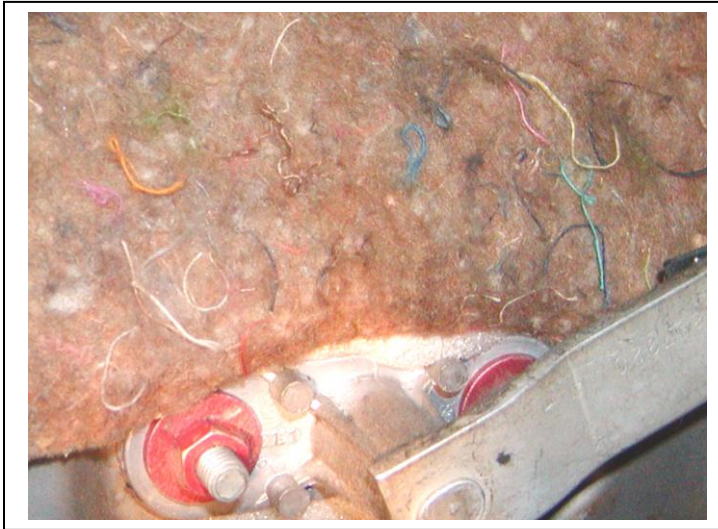
Original under dash cowl insulation. It is beige in color with **large multi color thread** fibers

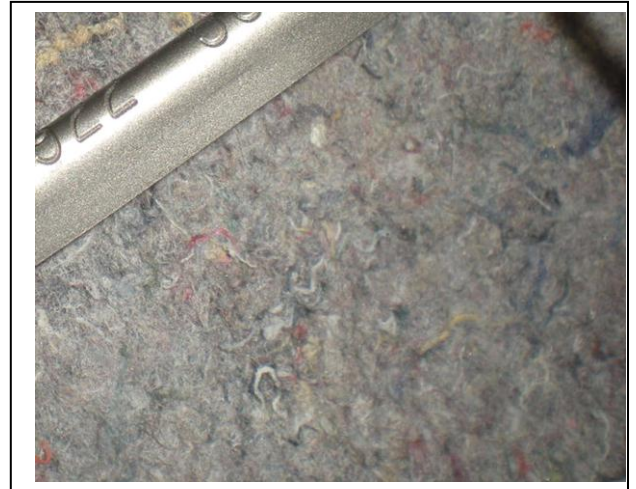
Aftermarket under dash cowl insulation. It is gray in color with small multi color thread fibers
