## T Section # 7 - Chassis - Frame and Underbody Review

### Section Summary

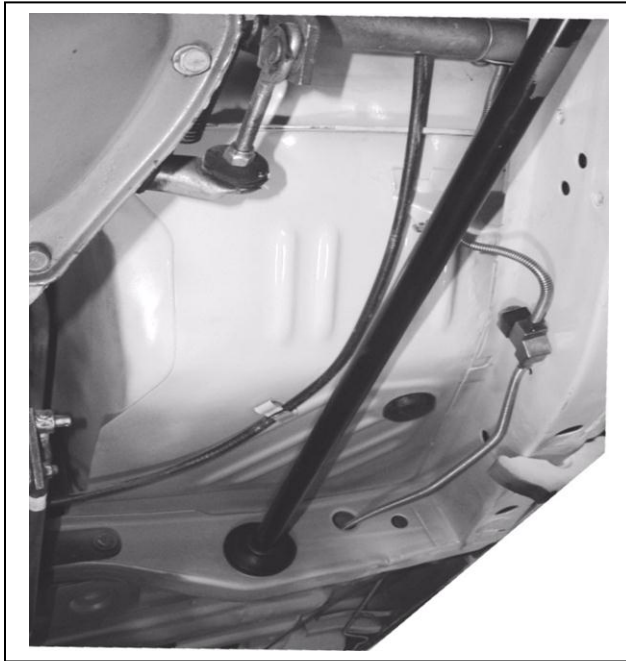
1970 Left front floor pan

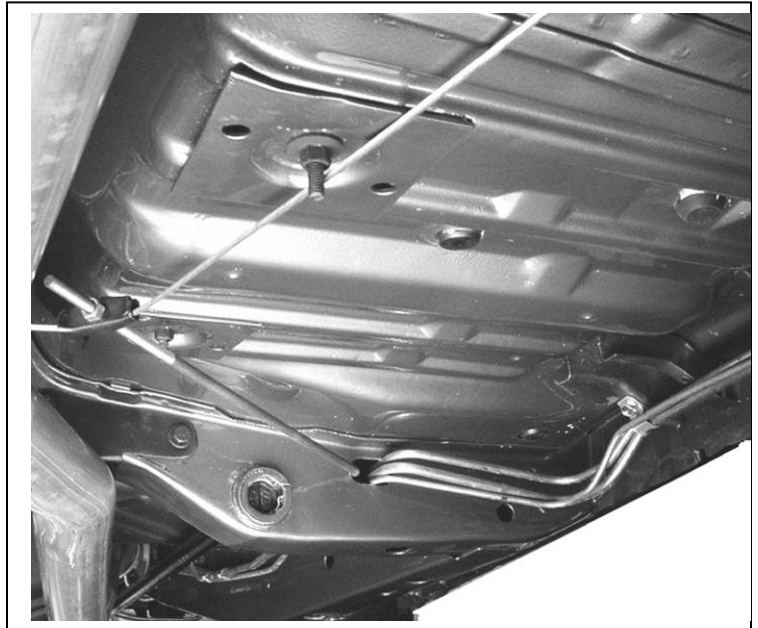
1971 right side floor pan

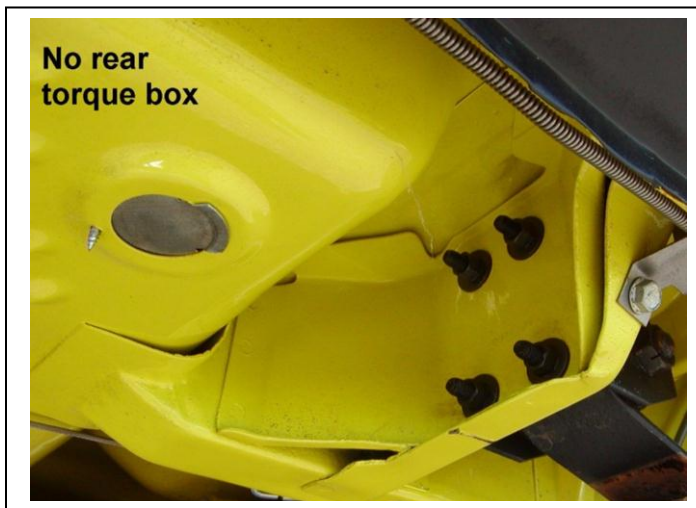
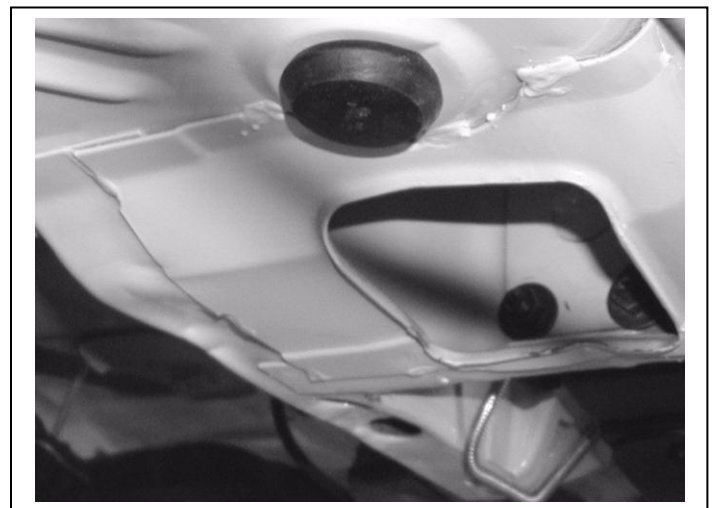
Left side rear pan with and without torque box

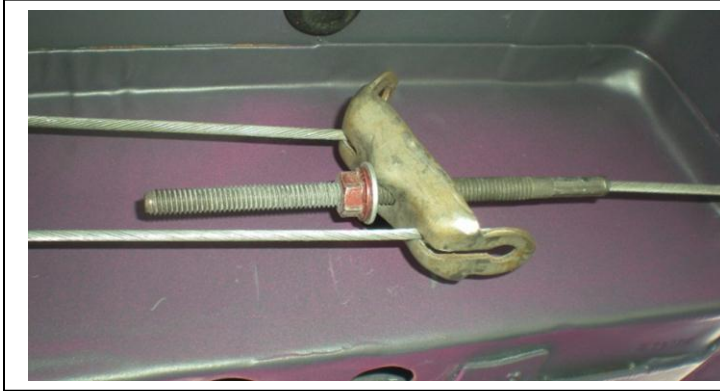
1970 Emergency brake adjuster. The bracket should be zinc plated and the adjusting nut should be plated red zinc dichromate.

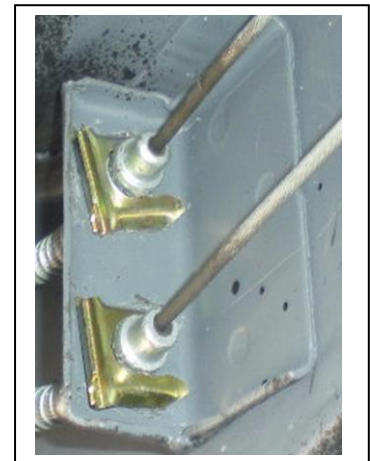
The retaining clips should be phosphate plated .

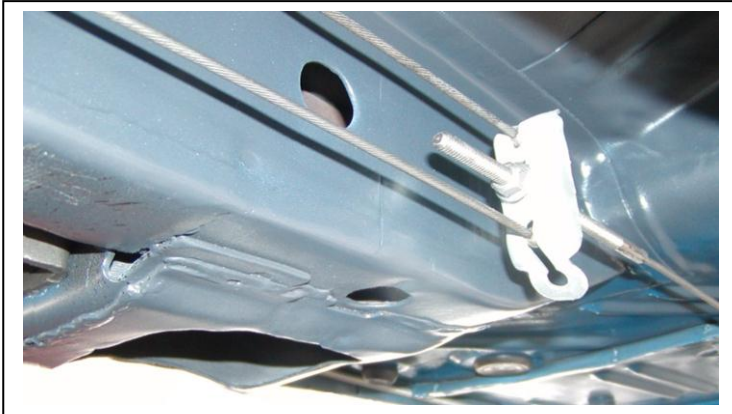
B body E brake equalized reference

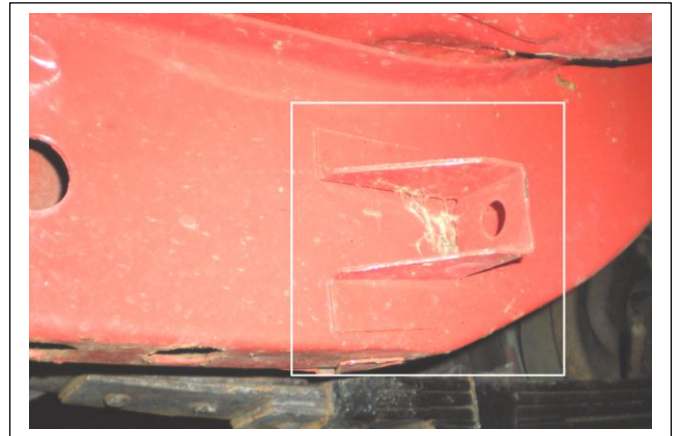
Parking brake cable support bracket position starting in 1971 on right hand frame rail

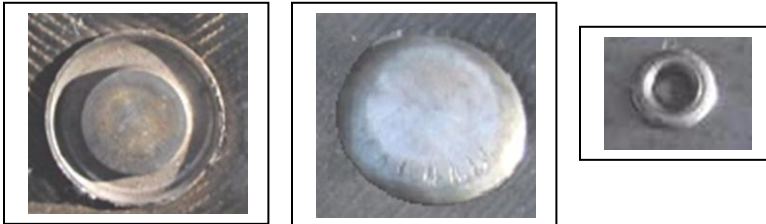
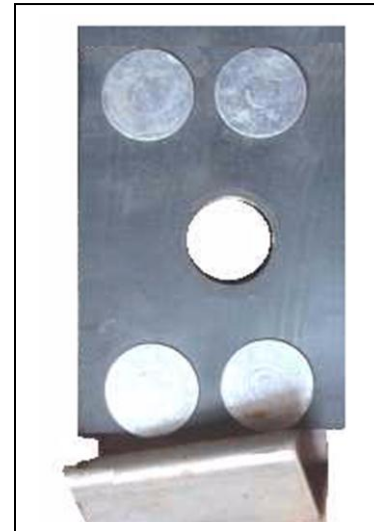
Aftermarket hanger

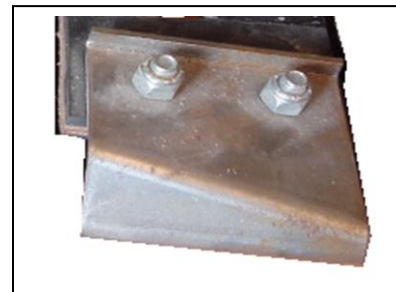
Aftermarket hanger back side. As you can tell rivets are not used.

**Note:** There have been some variations in the rivet head styles found. We have not determined if the on the left is an assembly line original or a dealer after market replacement. The back side of the rivets is almost identical for both.

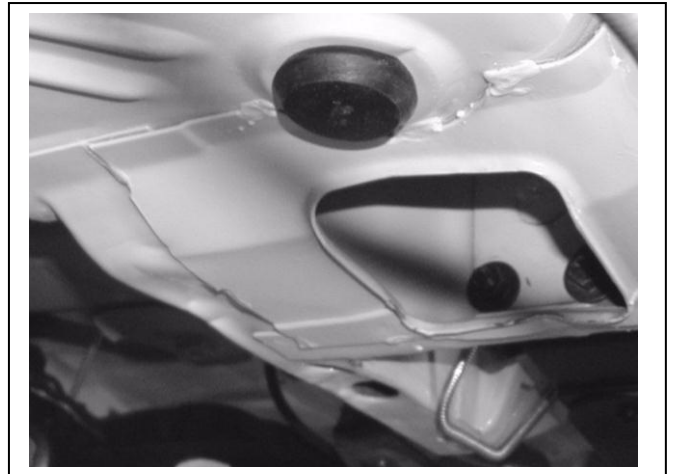
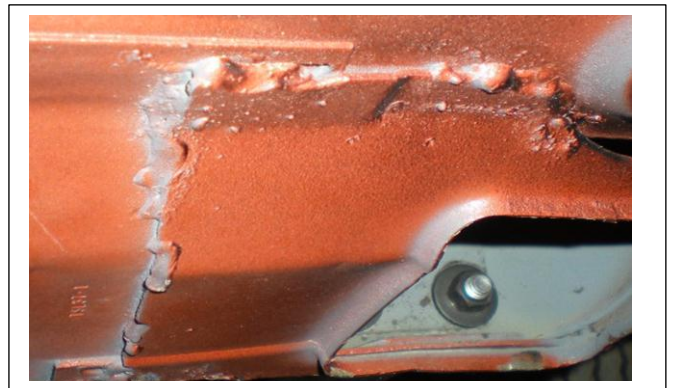
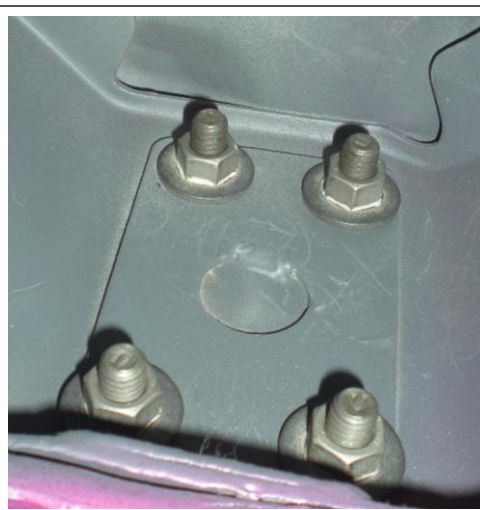
1970 440 + 6 or Hemi reference reinforcement plate inside of the rear torque box

These rear spring supports were stamped steel plates that were welded between the rocker panel and frame. They are located just in front of the rear leaf springs. They were required for all convertibles and cars with 440 engine and manual transmissions, 440+6 and 426 engines.

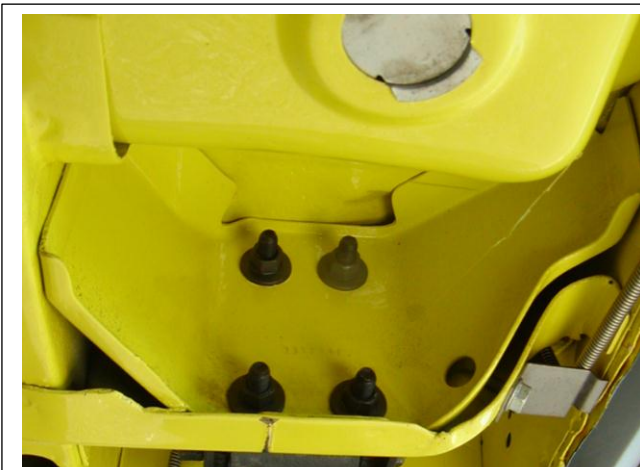
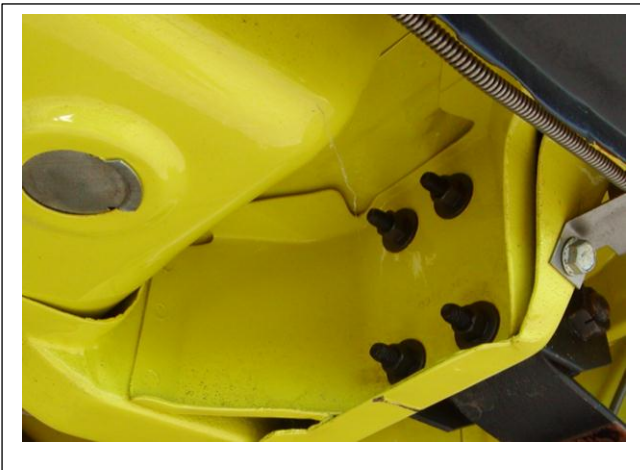
1971 standard rear frame without reinforcement box or plate .

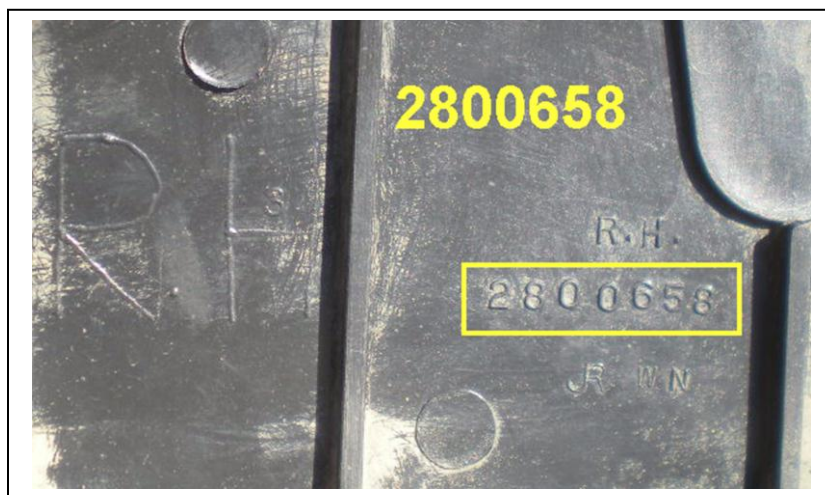
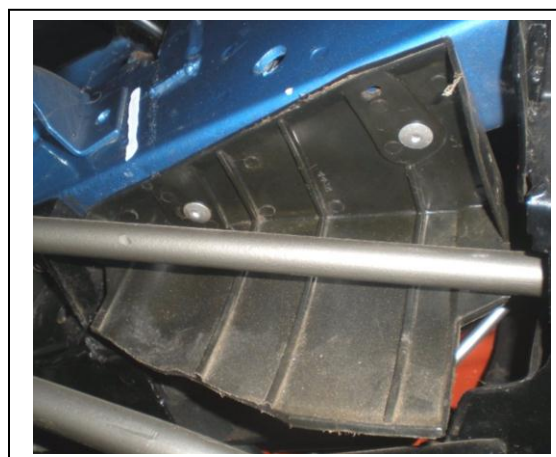
Shield reference RH Ref # 2800658. Vendor markings molded into the plastic JR WN.

There is one black plastic splash shield mounted to the RH and LF front frame. It is located between the K frame mounting bolts and above the strut rod. This shield should have the Chrysler part number and vendor code molded into the plastic. In general Hex washer head self tapping screws are used to secure the shields to the frame. However, large headed aluminum rivets are acceptable.
